# Building Conditions Assessments Vicksburg Square and BOQ Buildings

Draft Report Summary

# Building Conditions Assessments

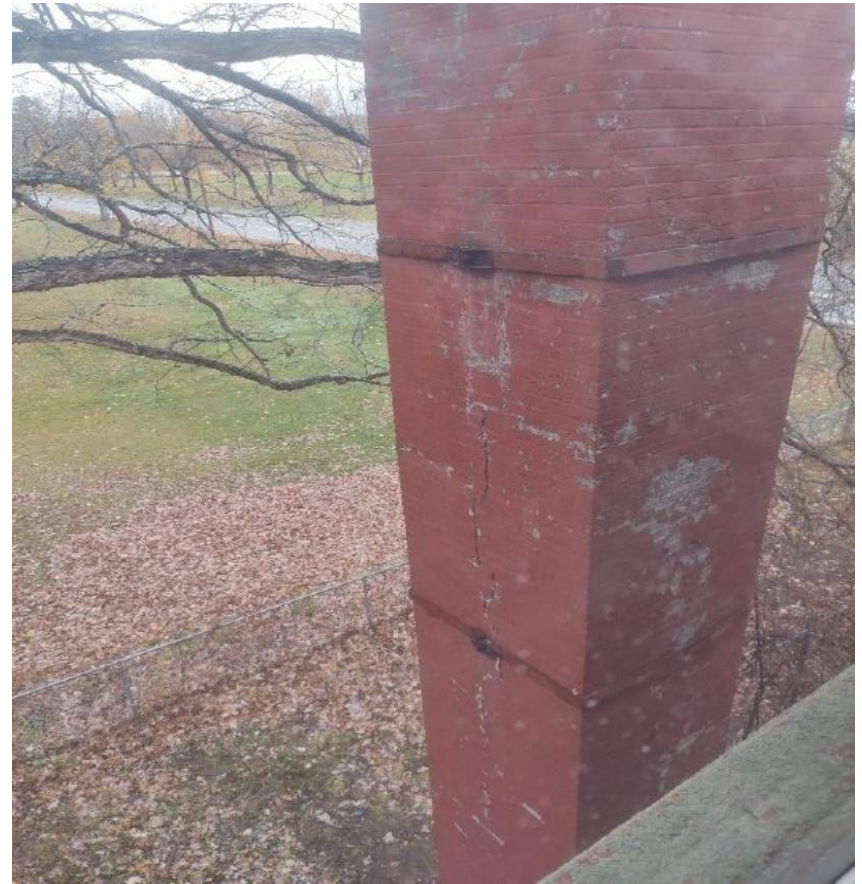
Image: Unbraced chimney, Washington Hall.  
(ICON Architecture, 2026.)

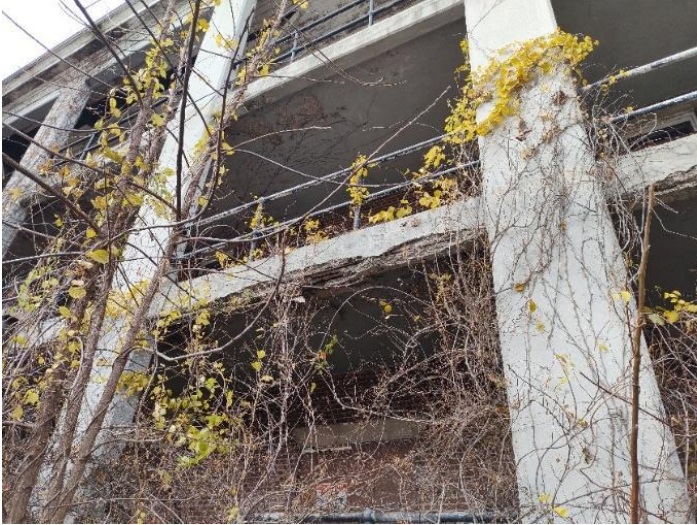
Images (clockwise from top left): Deteriorated concrete beams, slabs (Knox); failing roof framing at porches (Revere); deteriorated roof joists from water intrusion (Hale); deteriorated beams and exposed slabs (Allen). (ICON Architecture, 2026.)

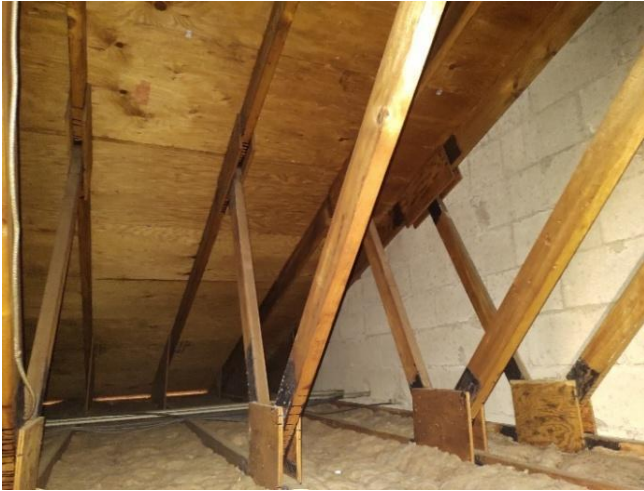
Images (clockwise from top left): Wooden trusses in good condition (BOQs); typical view of pipe trench (BOQs); Washington Hall roof (well past useful life); example of damaged exterior wall system (Washington Hall). (ICON Architecture, 2026.)
