### FORMER FORT DEVENS ARMY INSTALLATION PROJECT STATUS UPDATE

September 2020

Per- and Polyfluoroalkyl Substances (PFAS) Investigation and Sampling Updates

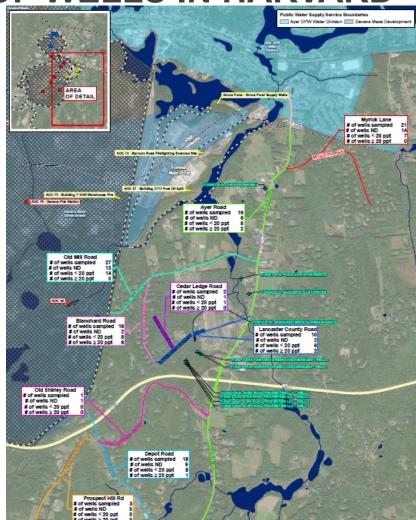
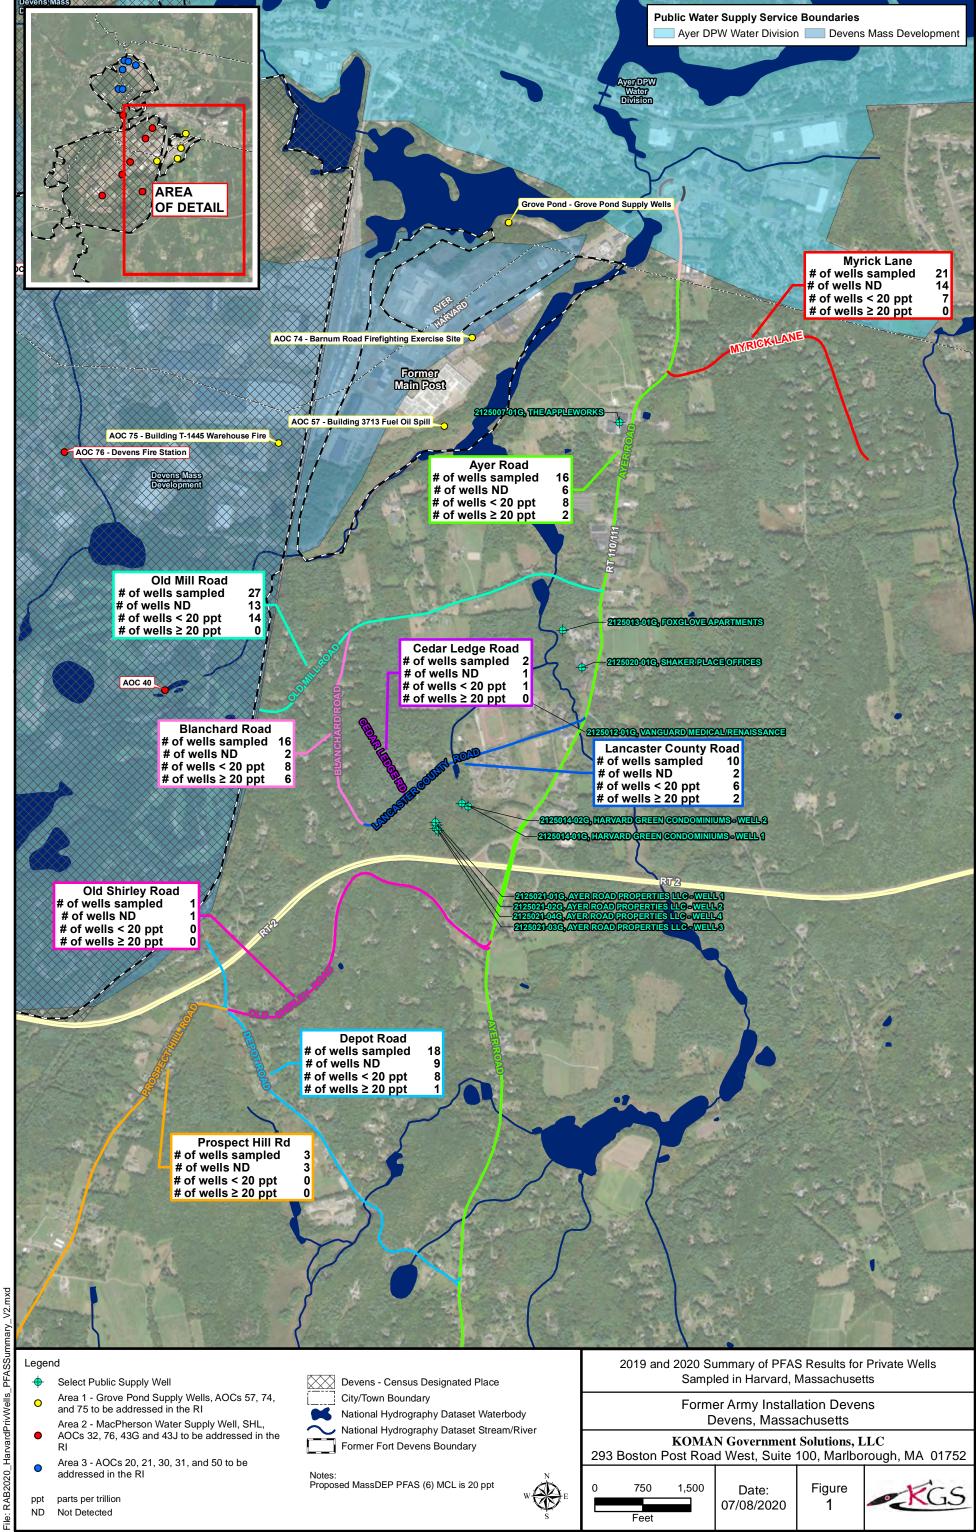
### **RESULTS OF SAMPLING OF WELLS IN HARVARD**

Harvard Private Well PFAS Results Summary Breakdown							
	Number of	Number	Number	Number			
Location	Wells	Exceeding	Detects	of Non-			
	Sampled	20 ppt	<20 ppt	Detects			
Myrick Lane	21	0	7	14			
Ayer Rd	16	2	8	6			
Old Mill Rd	27	0	14	13			
Blanchard Rd	16	6	8	2			
Cedar Ledge Rd	2	0	1	1			
Lancaster Cty Rd	10	2	6	2			
Old Shirley Rd	1	0	0	1			
Depot Rd	18	1	8	9			
Prospect Hill Rd	3	0	0	3			
Subtotals	114	11	52	51

No results exceeded the EPA LHA of 70 ppt

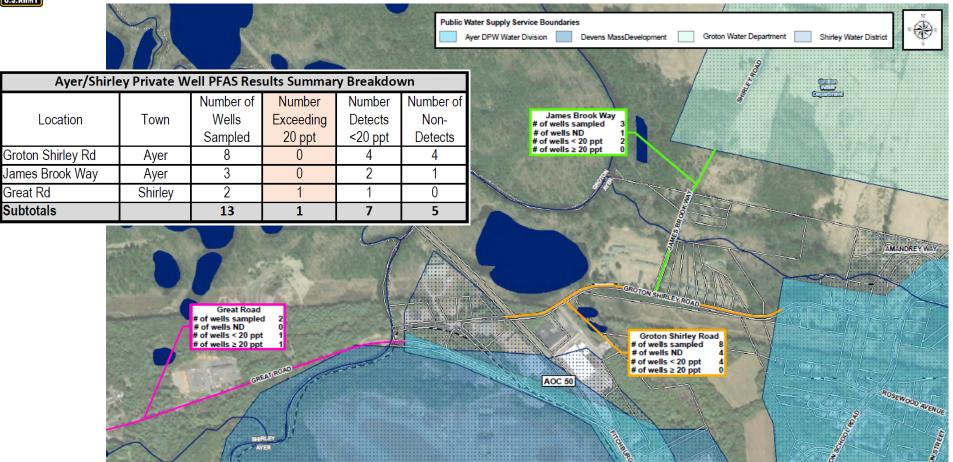
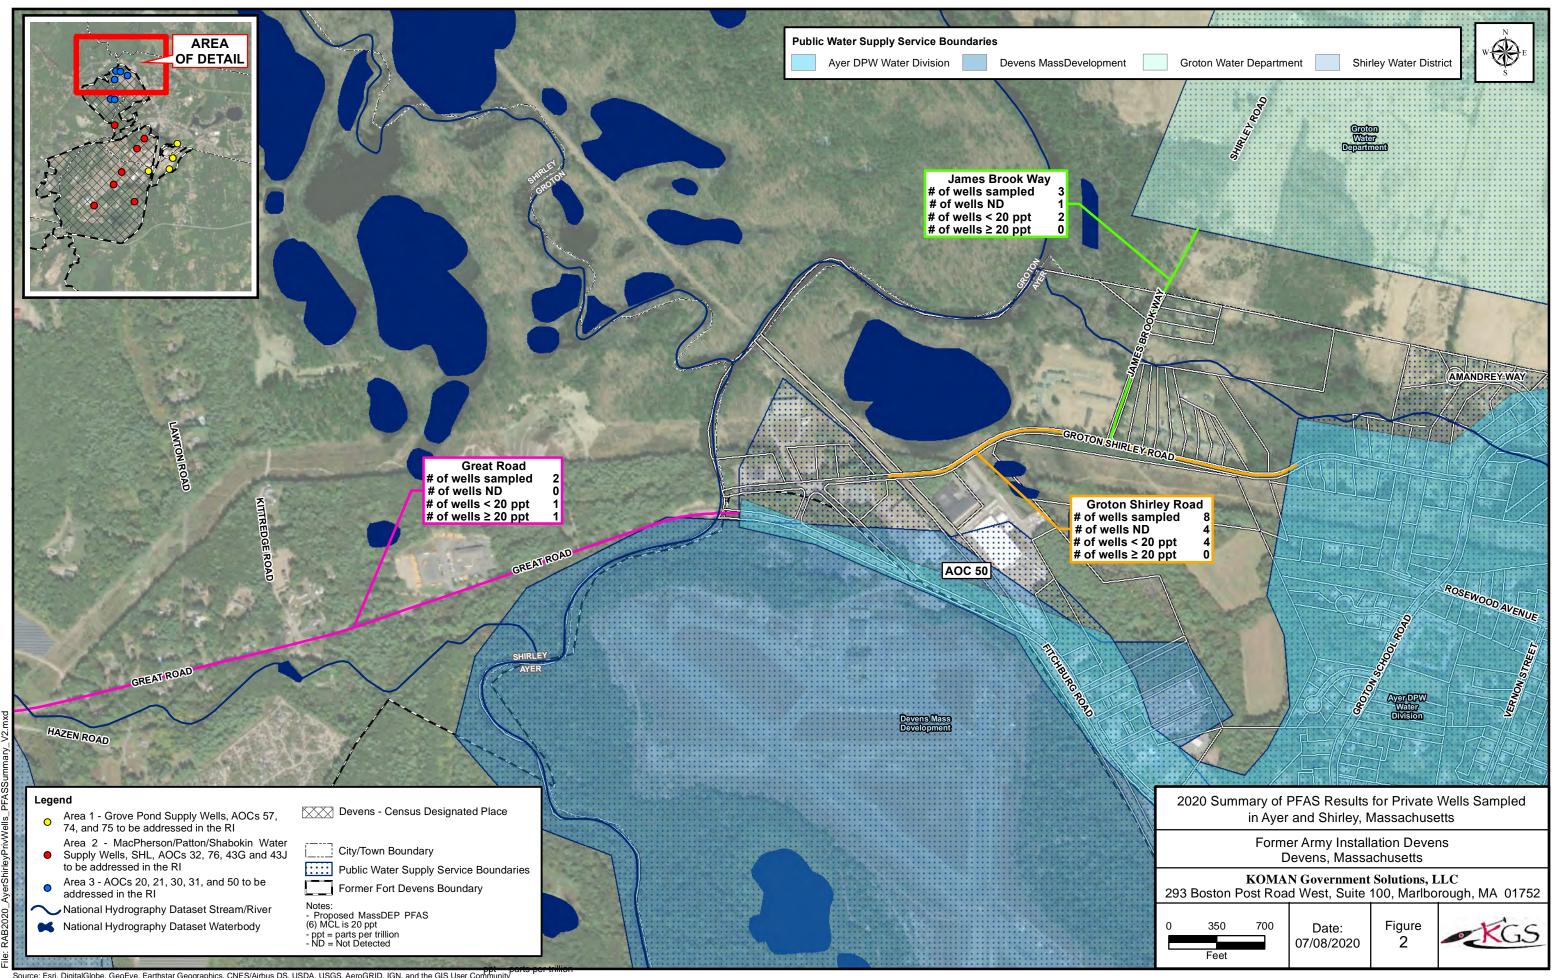
### WELL SAMPLING RESULTS IN AYER AND SHIRLEY

No results exceeded the EPA LHA of 70 ppt

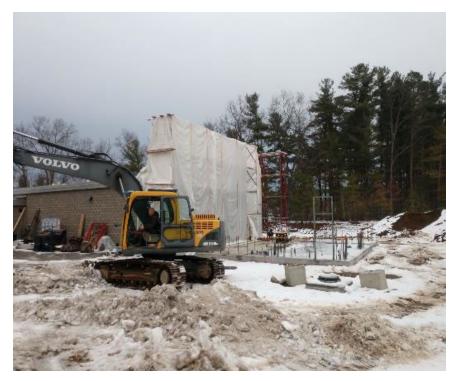
# UPDATE ON GROVE POND WELLFIELD ENVIRONMENTAL SERVICES COOPERATIVE AGREEMENT (ESCA)

Permanent upgrade to Grove Pond Water

Treatment Plant – New Ion Exchange (IX)

System

Will treat up to 2 million gallons per day

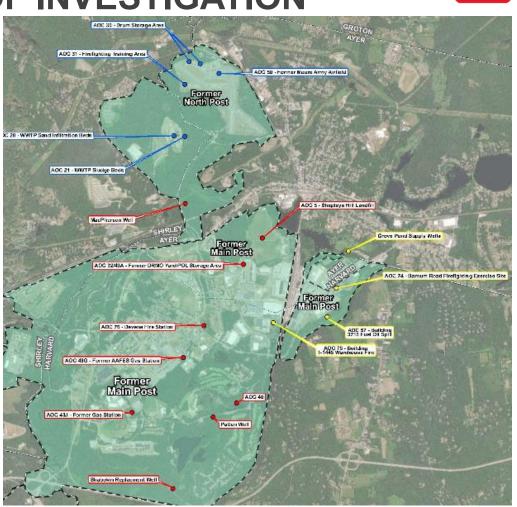
#### PFAS RI AREAS OF INVESTIGATION

RI Areas of Investigation – the areas of investigation were divided into Areas 1, 2, and 3 to facilitate mobilizing into the field quicker back in 2018. Each area of investigation is shown on the map within the specified area.

- Area 1 = yellow
- Area 2 = red
- Area 3 = blue

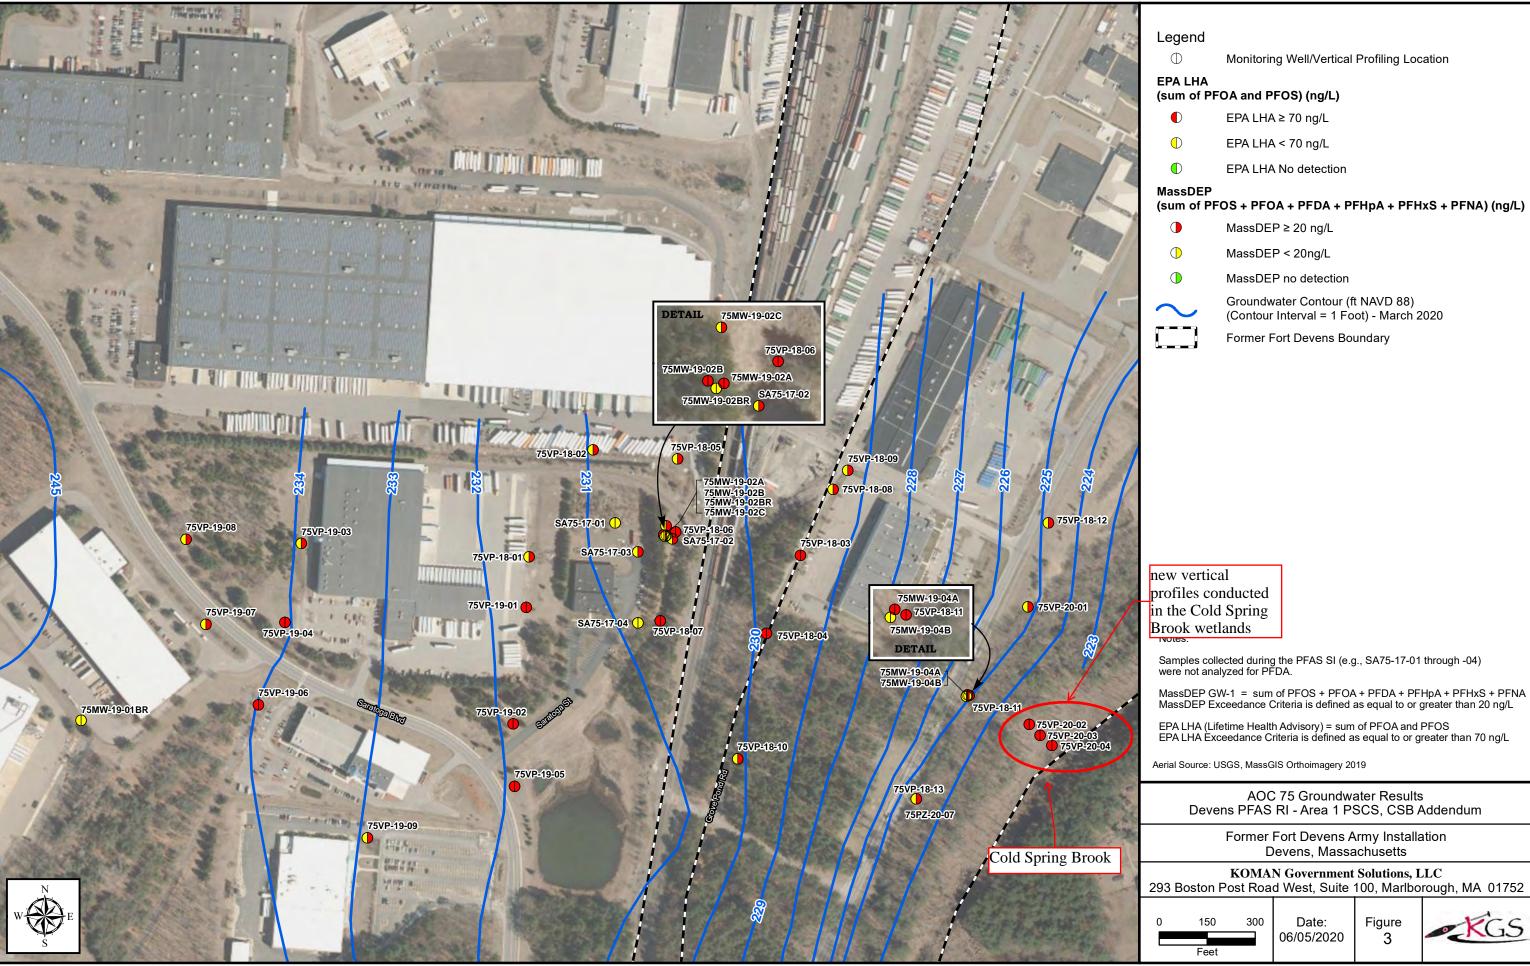
# RESULTS OF VERTICAL PROFILES CONDUCTED IN COLD SPRING BROOK WETLANDS – AOC 75

- Three vertical profiles were conducted starting at the edge of the wetlands. Samples were collected down to 32 and 35 ft below the top of the sediment.
- PFAS concentrations greater than the EPA LHA (70 ppt) and MassDEP GW-1 standard (20 ppt) were observed at all three locations. Concentrations decreased with distance from the shoreline (i.e., toward the center of the brook). The higher PFAS concentrations were shallower with increasing distance from the shoreline. These observations support our understanding that the groundwater from AOC 75 discharges to Cold Spring Brook/wetlands.
- The highest concentrations were detected at sample locations 75VP-20-02 at 8-10 ft below the top of the sediment (PFOA + PFOS = 320 ppt and the sum of the six MassDEP GW-1 standard compounds is 1,010 ppt)

The profile results are shown on the following maps, which show the maximum concentration detected at each location regardless of depth.

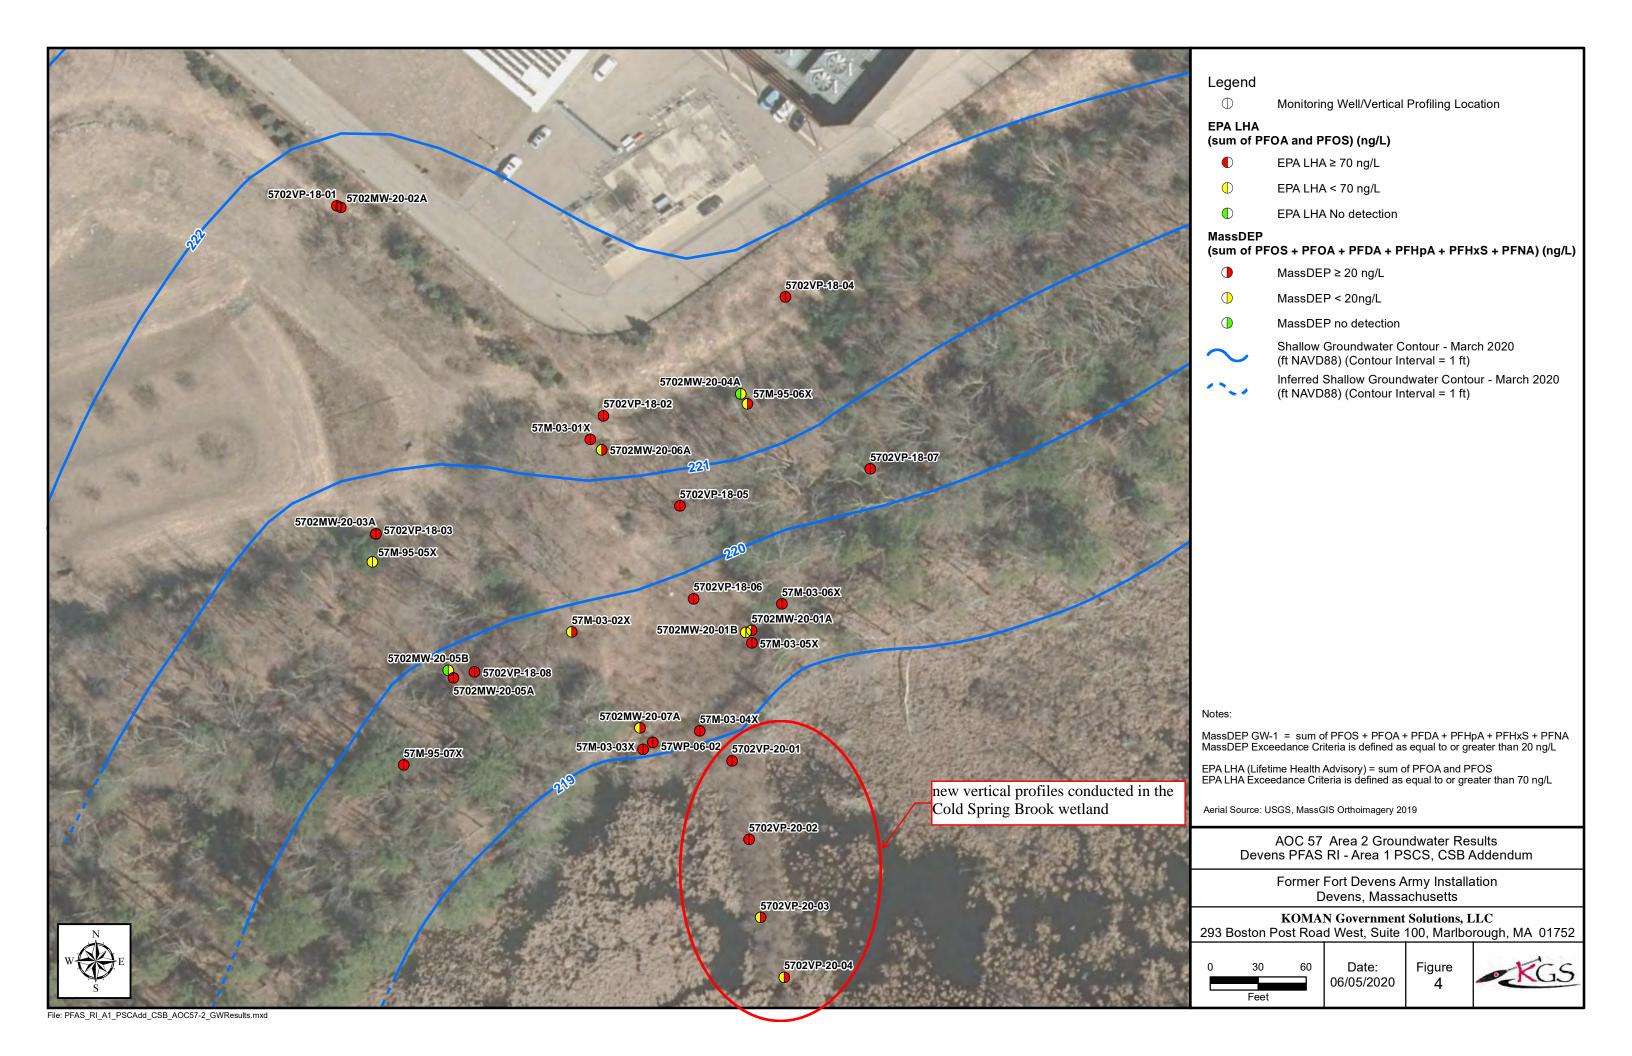
### RESULTS OF VERTICAL PROFILES CONDUCTED IN COLD SPRING BROOK WETLANDS – AOC 57 AREA 2

- Four vertical profiles were conducted on the containment dam starting at the edge of the wetlands. Samples were collected down to 52 to 54 ft below the top of the dam. PFAS concentrations greater than the EPA LHA were observed at two locations and greater than the MassDEP GW-1 standard at all four locations.

- The highest concentrations were detected at 5702VP-20-02 at 10-14 ft below the top of the sediment (PFOA + PFOS = 769 ppt, the sum of the six MassDEP GW-1 standard compounds is 1,990 ppt).

- Concentrations were lowest at the location farthest from the shoreline (closest to the center of the brook). The highest concentrations in each profile became shallower with increasing distance as the profiles approached the center of the brook. These observations support our understanding that the groundwater from AOC 57 Area 2 is discharging to the brook/wetland.

- Upward vertical gradients measured in monitoring wells and piezometers at the shoreline also support our understanding that groundwater at AOC 57 Area 2 discharges to the brook/wetland.

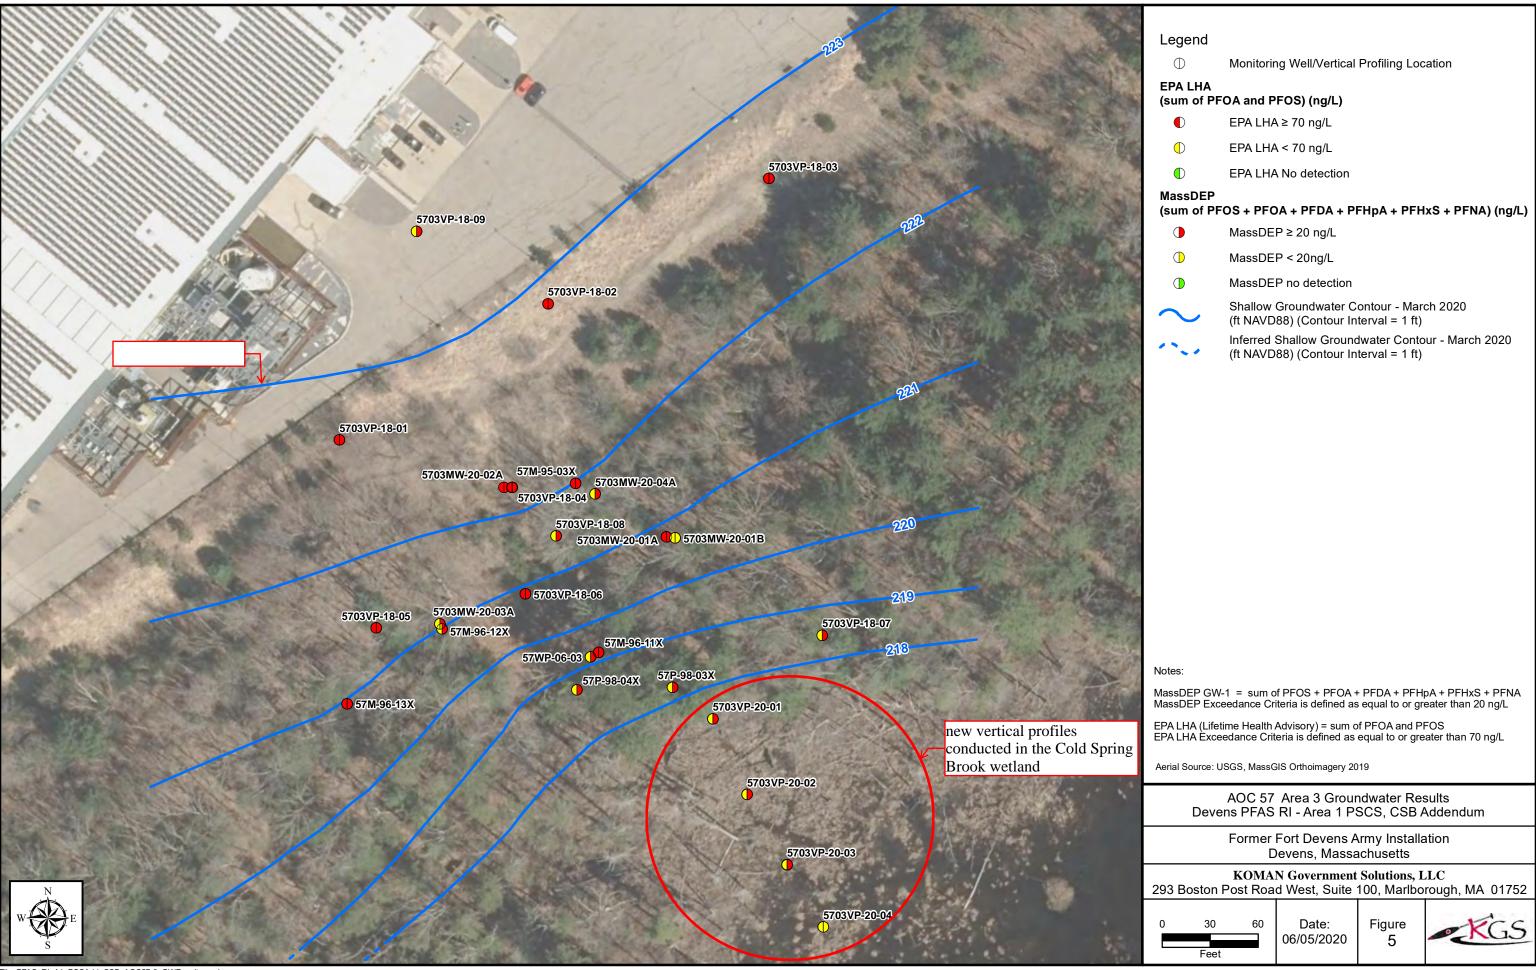
### RESULTS OF VERTICAL PROFILES CONDUCTED IN COLD SPRING BROOK WETLANDS – AOC 57 AREA 3

- Four vertical profiles were conducted starting at the edge of the wetlands. Samples were collected down to 32 and 37 ft below the top of the sediment. None of the locations had PFAS concentrations greater than the EPA LHA. Three locations had concentrations greater than the MassDEP GW-1 standard.

- The highest concentrations were detected at 5703VP-19-01 at 30-32 ft below the top of the sediment (PFOA + PFOS = 28.0 ppt, the sum of the six MassDEP GW-1 standard compounds is 93.9 ppt).

- Concentrations decreased with distance from the shoreline (i.e., toward the center of the brook) and higher concentrations became shallower with increasing distance from the shoreline. Both of these observations support our understanding that the groundwater from AOC 57 Area 3 discharges to the brook/wetlands.

- Upward vertical gradients measured in monitoring wells and piezometers at the shoreline support our understanding that groundwater at AOC 57 Area 3 is discharging to the brook/wetlands.

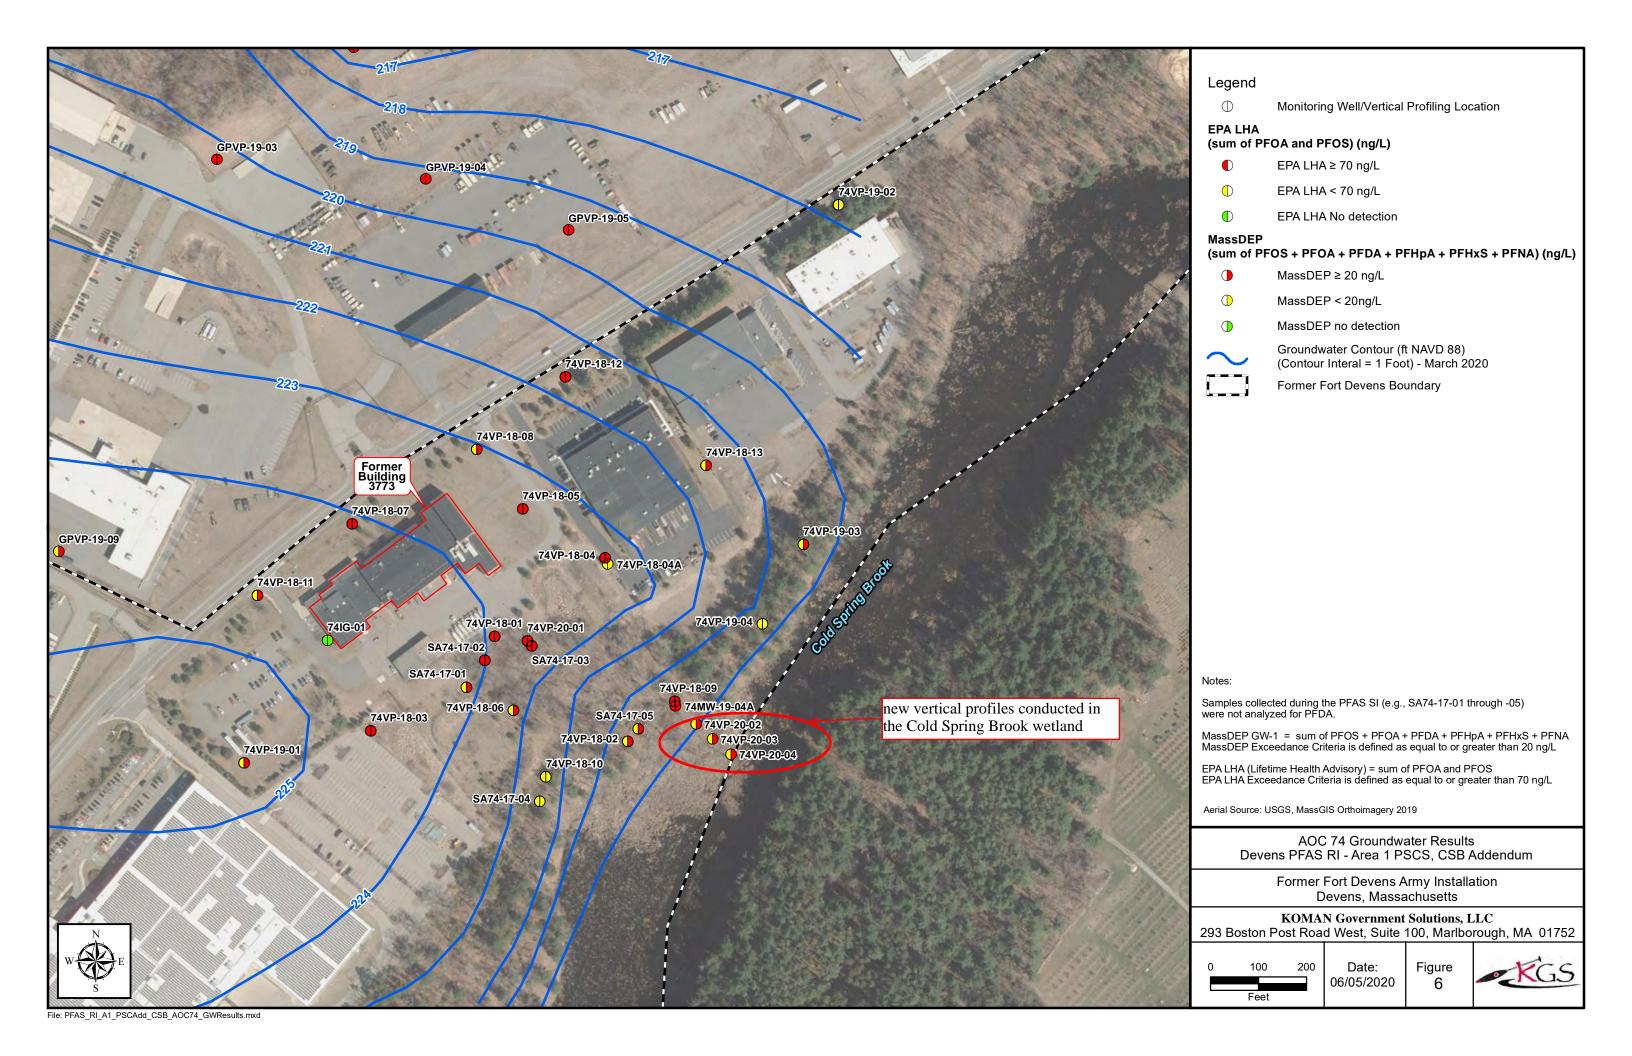
## RESULTS OF VERTICAL PROFILES CONDUCTED IN COLD SPRING BROOK WETLANDS – AOC 74

- Three vertical profiles were conducted starting at the edge of the wetlands. Samples were collected down to 27 to 37 ft below the top of the sediment. None of the locations had PFAS concentrations greater than the EPA LHA. All three locations had concentrations greater than the MassDEP GW-1 standard.

- Concentrations were lowest at the location farthest from shore and higher concentrations became shallower with increasing distance from the shoreline. Both of these observations support our understanding that the groundwater from AOC 74 is discharging to the brook/wetland.

- The highest concentrations (PFOA + PFOS = 68.4 ppt, the sum of the six MassDEP GW-1 standard compounds is 102 ppt) were detected at 74VP-20-03 at 15-17 ft below the top of the sediment.

- Upward vertical gradients measured in monitoring wells and piezometers at the shoreline support our understanding that groundwater at AOC 74 is discharging to the brook/wetland.

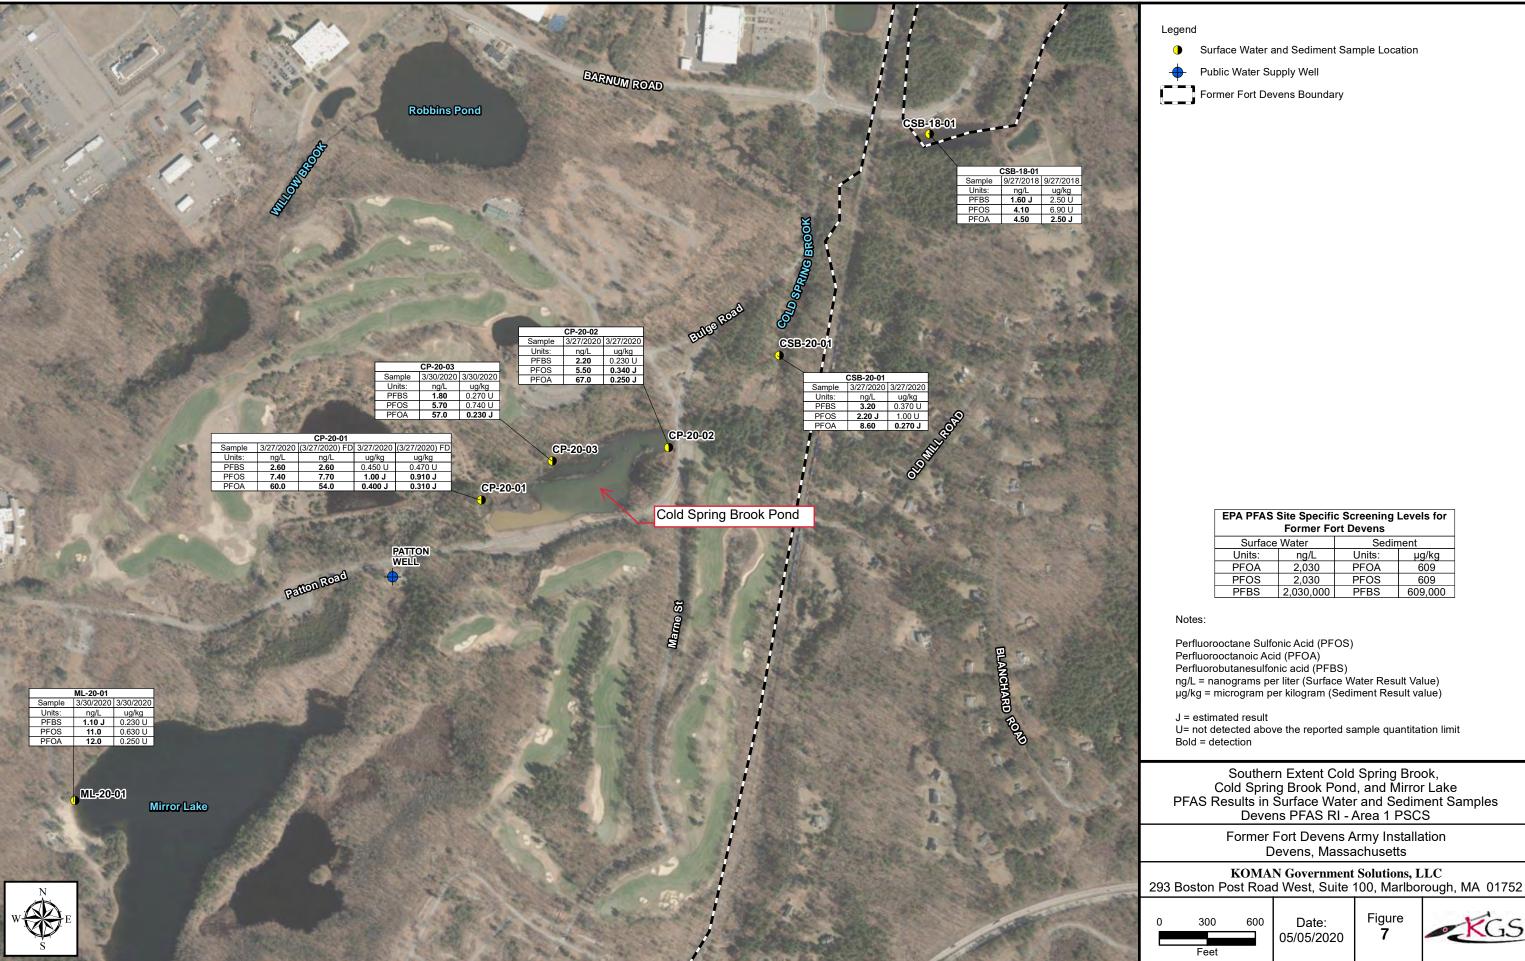
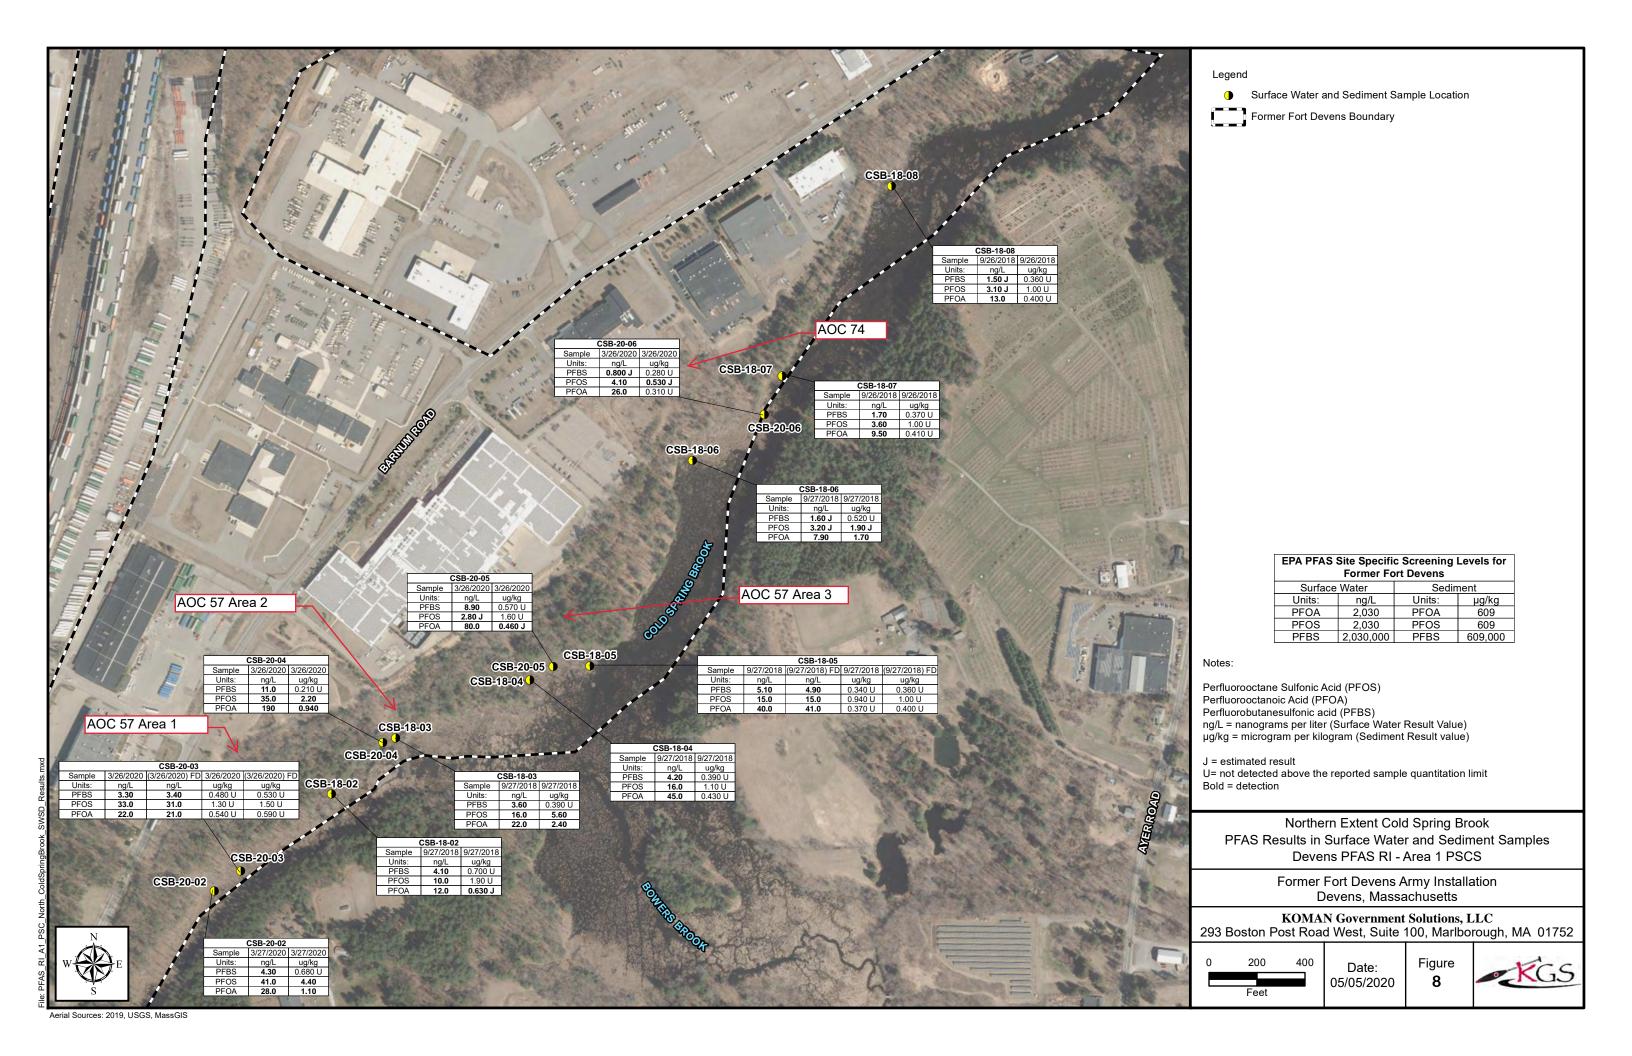
Ten surface water and sediment samples were collected from Mirror Lake, Cold Spring Brook Pond, and Cold Spring Brook in March 2020.

- The location at Mirror Lake was collected near the beach.
- The three locations in Cold Spring Brook Pond were to assess potential impact to the pond that may have been caused by contamination associated with AOC 40.

- Most of the locations in Cold Spring Brook were collected in areas where groundwater from the AOC 57 Area 2, AOC 57 Area 3, AOC 74, and AOC 75 are thought to be discharging to the brook/wetland

- The results are shown on the following maps, along with previously collected samples.

- PFAS concentrations did not exceed EPA's site-specific screening levels which are:
  - o Surface water screening levels: PFOA = 2,030 ppt, PFOS = 2,030 ppt, PFBS = 2,030,000 ppt

- Sediment screening levels: PFOA 609 μg/kg, PFOS = 609 μg/kg, PFBS = 609,000 μg/kg
- Mirror Lake (1 location)
  - Surface water: PFOA = 12 ppt, PFOS = 11 ppt, PFBS = 1.1 ppt

- Sediment: PFAS was non-detect
- Cold Spring Brook Pond (3 locations)
  - Surface water maximum: PFOA = 67 ppt, PFOS = 5.7 ppt
- Cold Spring Brook (6 locations)

- Surface water maximum: PFOA = 190 ppt, PFOS = 41 ppt, PFBS = 11 ppt
  - Sediment maximum: PFOA = 1.1 μg/kg, PFOS = 4.4 μg/kg, PFBS = non-detect
  - Five of the locations were positioned in areas where groundwater from the AOC 57 Area 2, AOC 57 Area 3, AOC 74, and AOC 75 are thought to be discharging to the brook. The concentrations at these locations (CSB-20-02 through -06) had higher concentrations than other samples collected in the brook. The results suggest that groundwater from AOC 57 Area 2, AOC 57 Area 3, AOC 74, and AOC 75 is discharging to the brook/wetland.

- CSB-20-01 had low PFAS concentrations indicating a minimal impact from PFAS at this location.
